Performance of masonry buildings during the 2011 Lorca earthquake

L. Hermanns, A. Fraile, E. Alarcón & R. Álvarez

Universidad Politécnica de Madrid, España

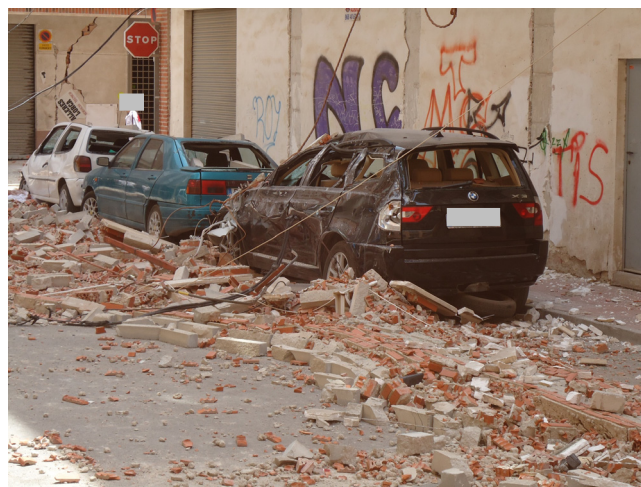
Figure 3. Street covered with rubble of damaged buildings

The situation on the streets was quite similar throughout the whole town. Figure 3 displays the situation of one of the streets in Lorca immediately after the main event took place.

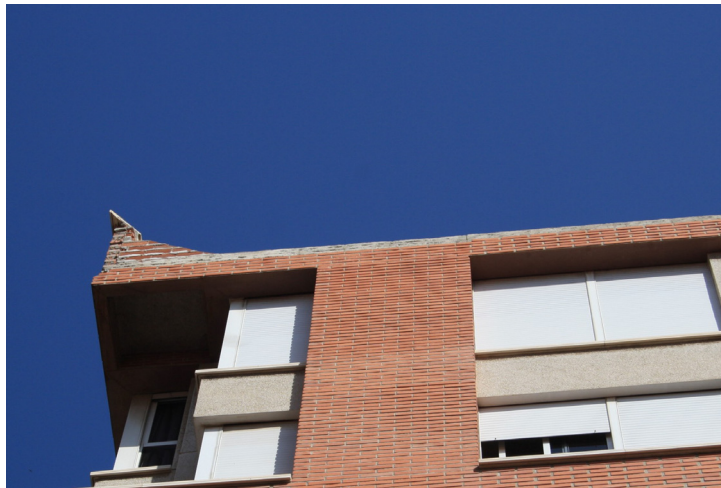
In the case of roof parapets, chimneys and to a minor extent infill panels at upper floors the failure was caused by inertia forces acting out-of-plane. It is well known that the resistance of masonry walls to out-of-plane moments is much lower than that of R.C. frames. As a consequence the interaction between the frames and the infill panels is very limited in this particular loading scenario as the failure of the infill panel changes the structural properties at a very low load level. Regarding unreinforced roof parapet walls some codes (FEMA 2011) point out the significant falling hazard related to this type of architectural components. Figure 4 shows one of the parapets that partially collapsed confirming thereby the importance of studying the seismic behaviour of non-structural components. The structure of this particular building did not suffer significant damage whereas the roof parapet almost completely collapsed.

Figure 4. Building with a almost completely collapsed parapet wall

This type of incoherence in terms of the seismic behaviour of different components of the same building should be avoided. It is important to note that the acceleration at roof level may be significantly higher than that at ground level due to the dynamic properties of the building. In addition, the bending moment capacity at the contact surface at roof level is usually quite small if the parapet wall is not adequately anchored. Not only parapet walls failed at this load level but also chimneys on flat roofs.

The falling hazard of damaged parapet walls is well known and addressed in several guidelines like (FEMA 2011). The importance of non-structural elements in the context of a seismic analysis should be evaluated taking into account their damage potential, not their cost.

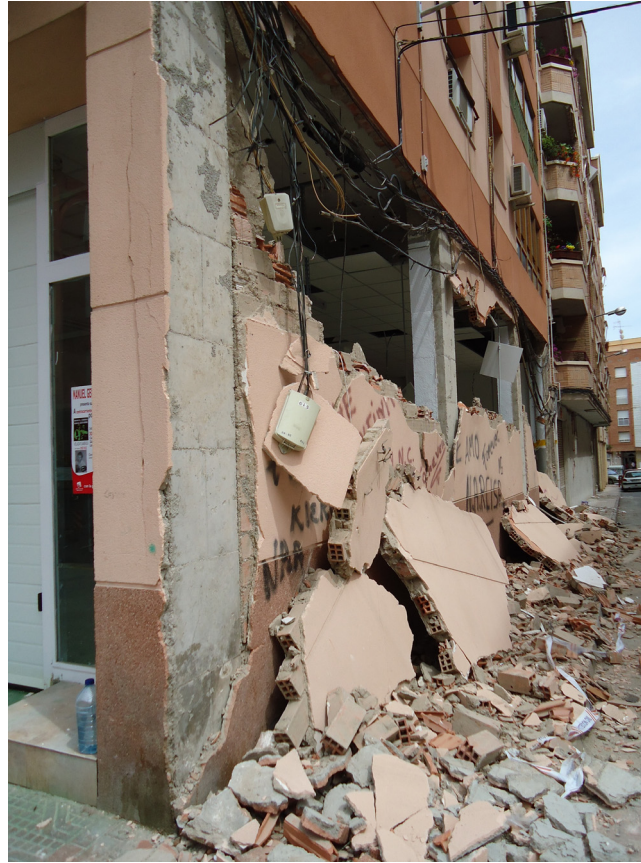
On lower floors the failure of masonry infill panels was caused by excessive in plane loads, displacements of the frame structure (see Figure 5) and in some cases by pounding of adjacent buildings. The interstorey height at ground floor level is usually higher than that of the upper floors as the ground floors are usually occupied by shops. In these cases both the stiffness of the framing structure and that of the masonry infill are comparable and the resistance of the infill panels is significant permitting thereby important interactions like a force transfer from the slightly cracked masonry wall to the surrounding frame structure. Although in some cases a combination of the two different failure mechanisms described above was observed, in general, the first one was more often observed on upper floors and the second one on lower floors.

Figure 5. Damaged masonry infill walls at ground floor

If the masonry infill panels are not included in the structural model that is used to study the seismic behaviour of the building, the non-structural infill walls should be designed and built with gaps to accommodate frame drifts; this solution is also known as isolated infill.

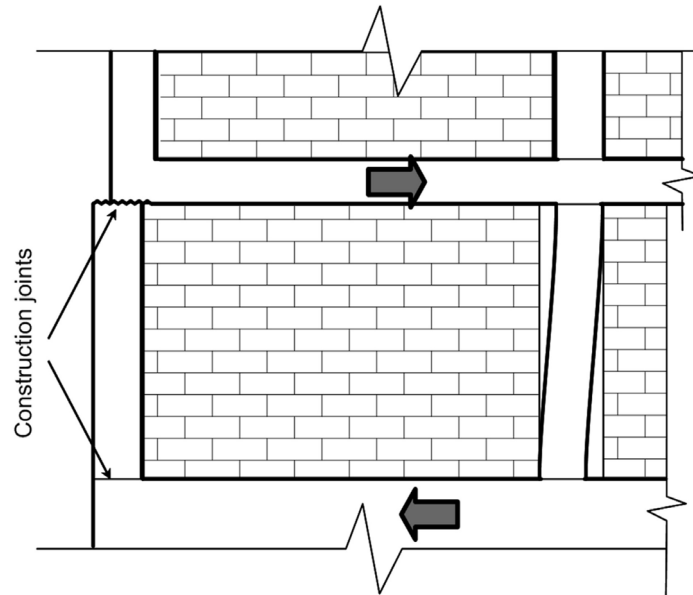
Joints are usually critical points in structures and many efforts have been put into the study of its behaviour. The importance of an adequate design is widely recognized however, quality control during construction is also very important. Construction joints in columns are usually located at the undersides of the slabs and beams as shown in Figure 9.

Figure 9. Failure at the construction joint of beam-column connection

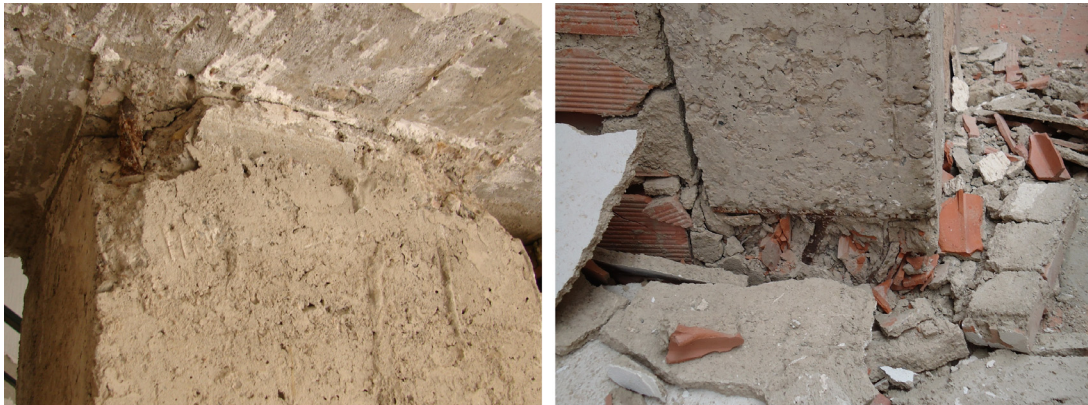
Failures of the contact surface were observed in several occasions (see Figure 10).

Figure 10. Examples of failure at the construction joint of a beam-column connections

This type of failure was observed particularly often in end bays of the exterior R.C. frames.

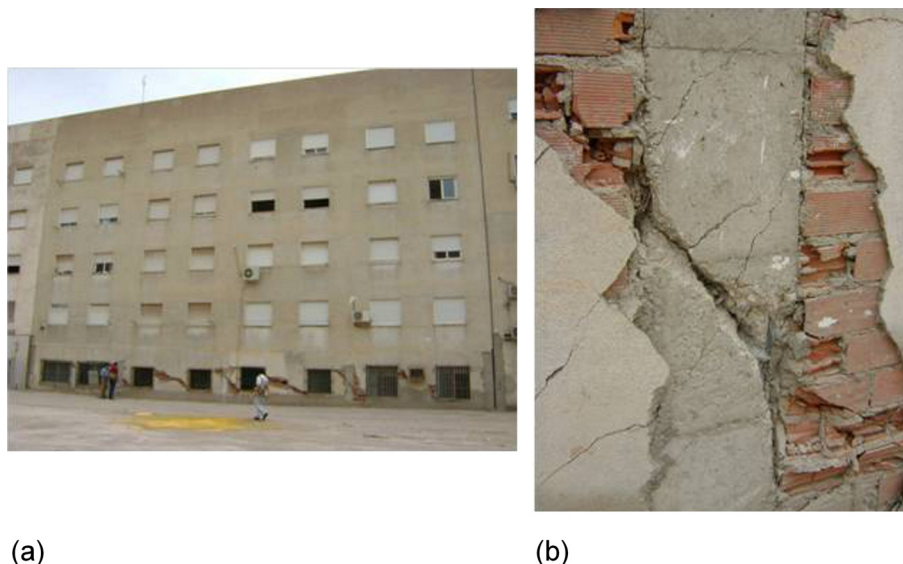
In general crack propagation in the infill panels indicates the position of the traction diagonal that connects two beam-column connections however, in some cases the cracks in the infill panels developed laterally displaced crossing the column at mid height like in Figure 12 b.

Figure 12. Example of cracks crossing a column at mid-floor height. Building (Fig. 12 a) Detail (Fig. 12 b)
